# Manhole Inspection Summary

Manhole # S63Q\_\_002MH

Insp Date: **9/1/09 9:17 AM**

**Location** Address: **SUN PRODUCTS**

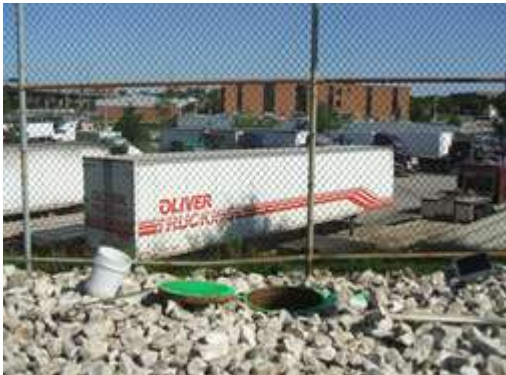
Location View

Comments **NRV2 - THIS WAS A BURIED MANHOLE. VERIFIED BY CCTV: 0806, SETUP J0411, VIDEO 277**

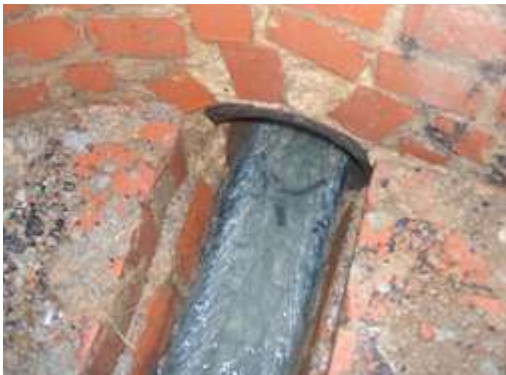
Defect 1

CRACKED PIPE SEAL O12

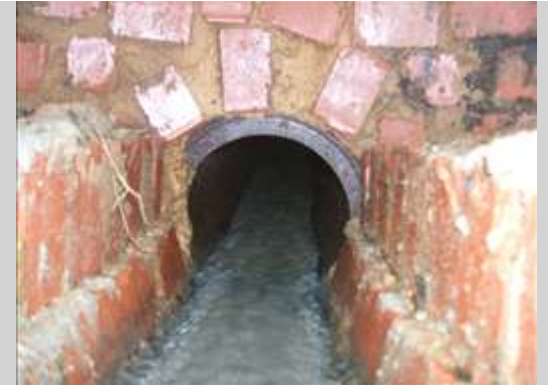
12 O'Clock Outflow

8 in. Circular Gravity Sewer  
Pipe Out @ 12 O'Clock

Infiltration: **Evidence** Pipe Seal Cond: **Cracked**

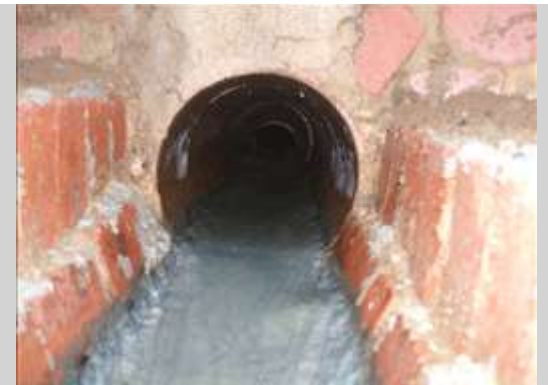
6 O'Clock Inflow

8 in. Circular Gravity Sewer  
Pipe In @ 6 O'Clock

Infiltration: **None** Pipe Seal Cond: **Sound**
